GT-210280

9 March 2022

Leak tightness of PVC fittings with hydrogen

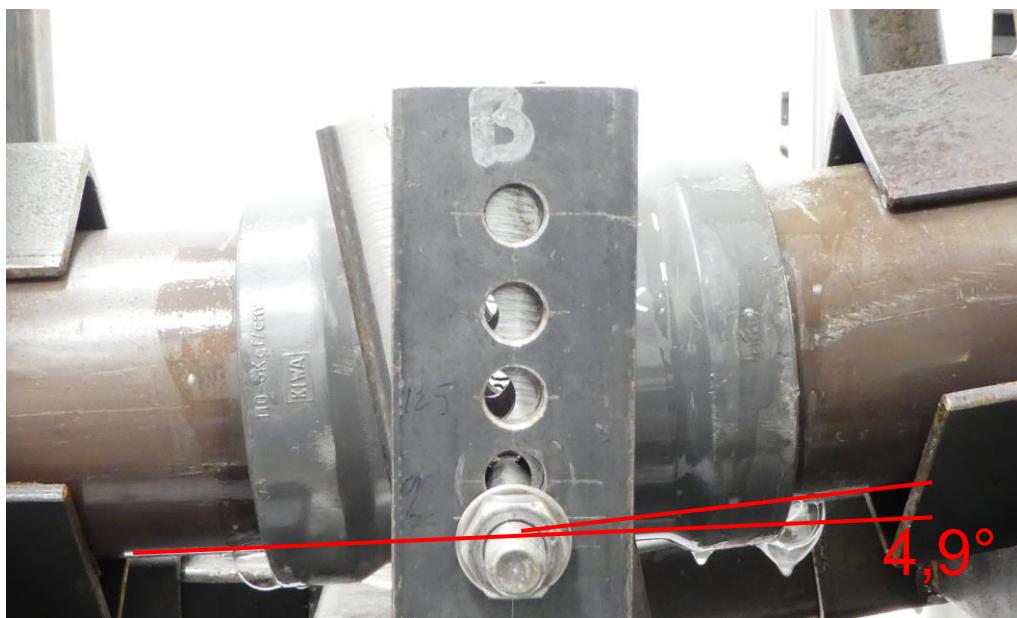
*Figure 11 Angle of deflection at the moment of leakage of PVC 2011-088
(to make the leak visible, leak detection spray was used)*

These results show a maximum angle of deflection of approximately 5° for PVC -U joints after ageing with hydrogen.
The angle of deflection of the PVC-Hi joints could not be measured as the test rig reached its maximum capability. The maximum angle of deflection is therefore greater than 30° after ageing with hydrogen.

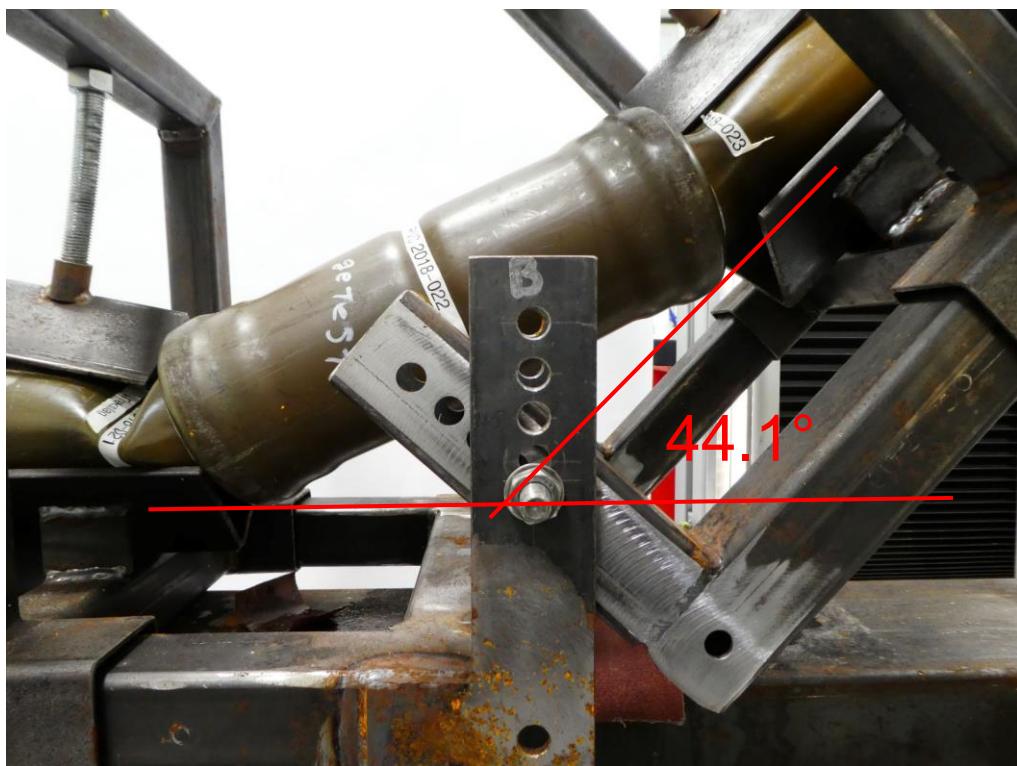
Figure 12 Maximum angle of deflection of the test rig reached (PVC 2018-022). No leakage occurred.

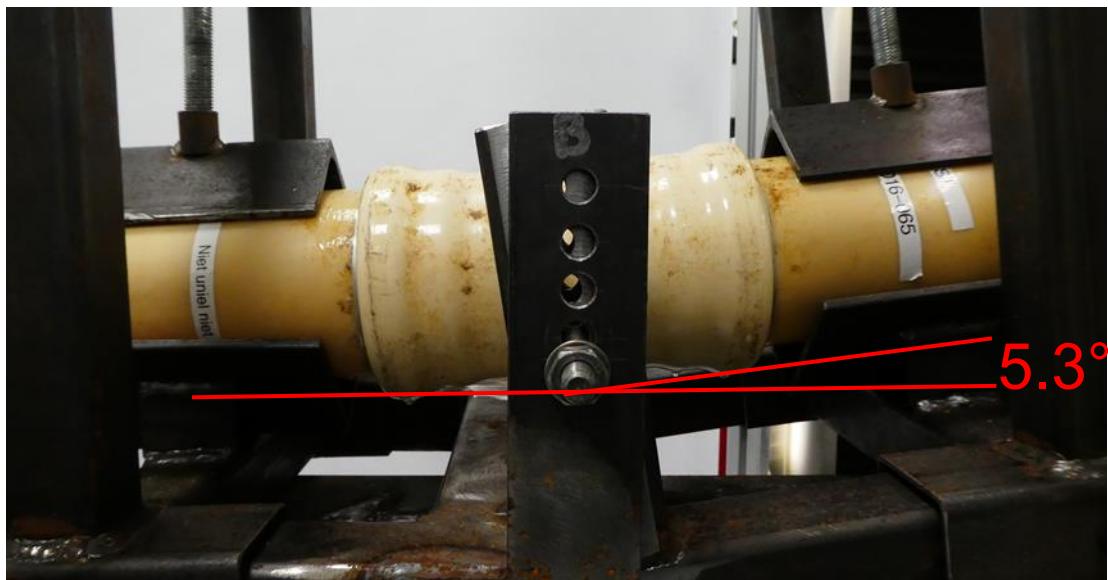
Figure 13 Angle of deflection at the moment of leakage of sample PVC 2016-064

As relative big differences in angles of deflection are measured between PVC-U joints, some additional investigations have been made. Especially the shape of the rubber sealing rings could be of importance. It is known that in rare cases only O-rings are used, whereas normally a lip-ring is used. Due to the shape, the lip-ring is expected to have a better resistance against angular deflection. To see whether the lip-ring was used two PVC-U joints aged with hydrogen were cut in the axial direction. The result of PVC 2016-064 is shown in figure 21. On the pipe, which was originally inserted in the socket, the impress of the rubber sealant ring is visible (lower part of the photograph). It clearly shows that the sealant ring is of the lip-type, but also that the lip is torn-off of the body of the ring. It is unclear if this is caused by the experiment that is performed or if this was already the case before the executing of the test. The second joint investigated is PVC 2011-088. This ring is also of the lip-type. This lip-ring is fully intact. The measured relative low angle of deflection is probably not correlated to the poor quality of the lip-ring from sample PVC 2016-064.

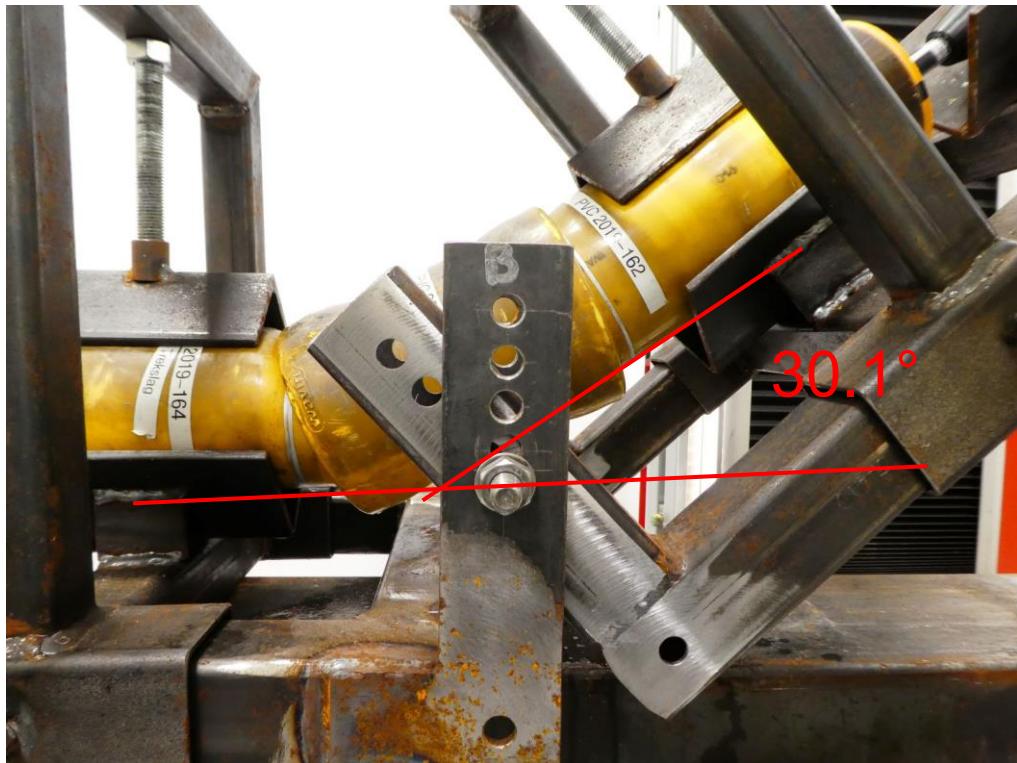
*Figure 14 Maximum angle of deflection of the test rig reached (PVC 2019-163). No leakage occurred.*

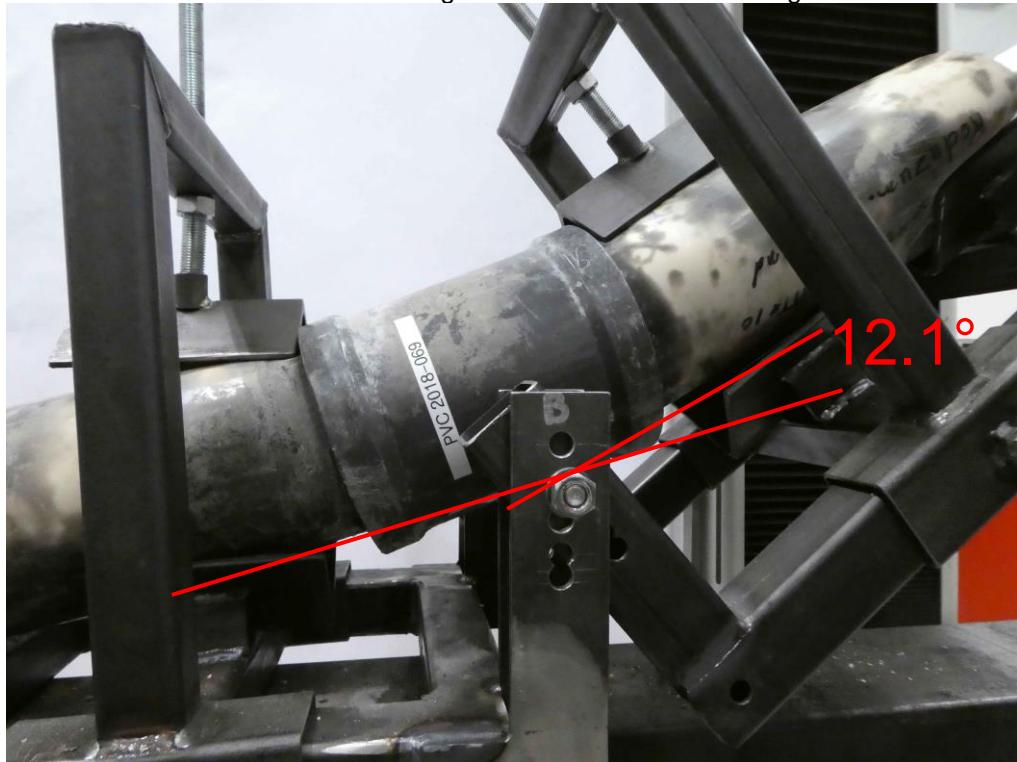
*Figure 17 Angle of deflection at the moment of leakage of unaged PVC 2018-069*

These results show a range of maximum angles of deflection of approximately >9° to 28° for DN 110 mm and 12° for DN 160 mm PVC -U joints without ageing
The maximum angel of deflection of PVC-Hi joint is not derived as the test rig reached its maximum capability. The maximum angle of deflection without additional ageing is therefore greater than 29°

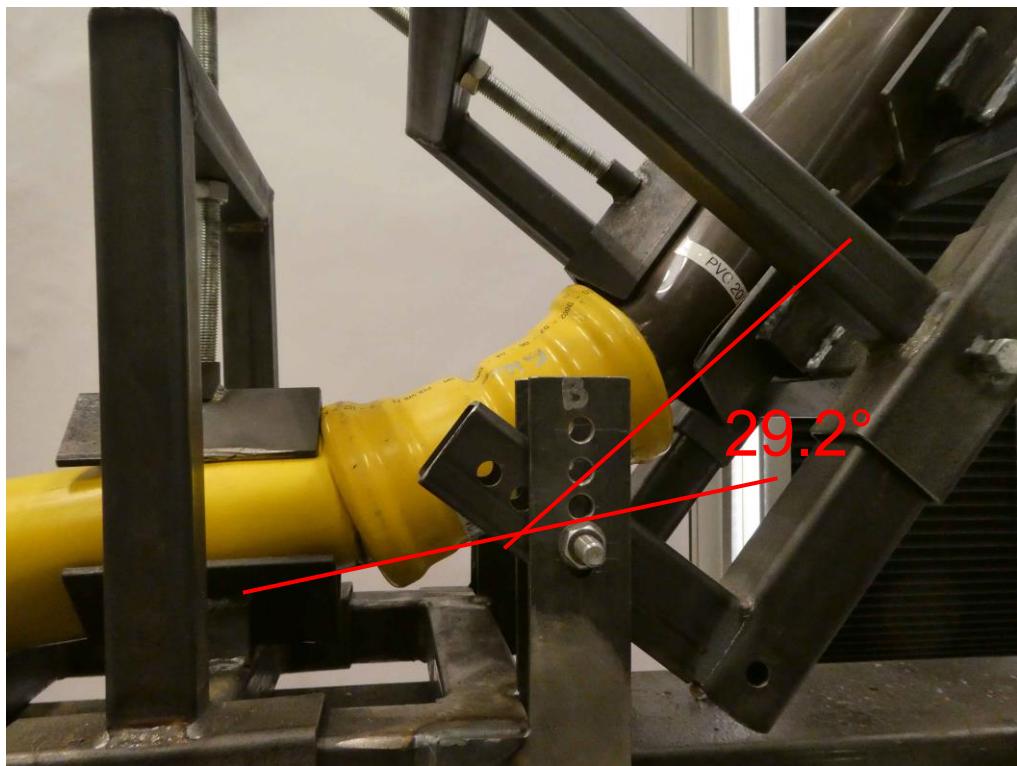
Figure 18 Maximum angel of deflection of test rig reached (PVC 2011-067). No leakage occurred

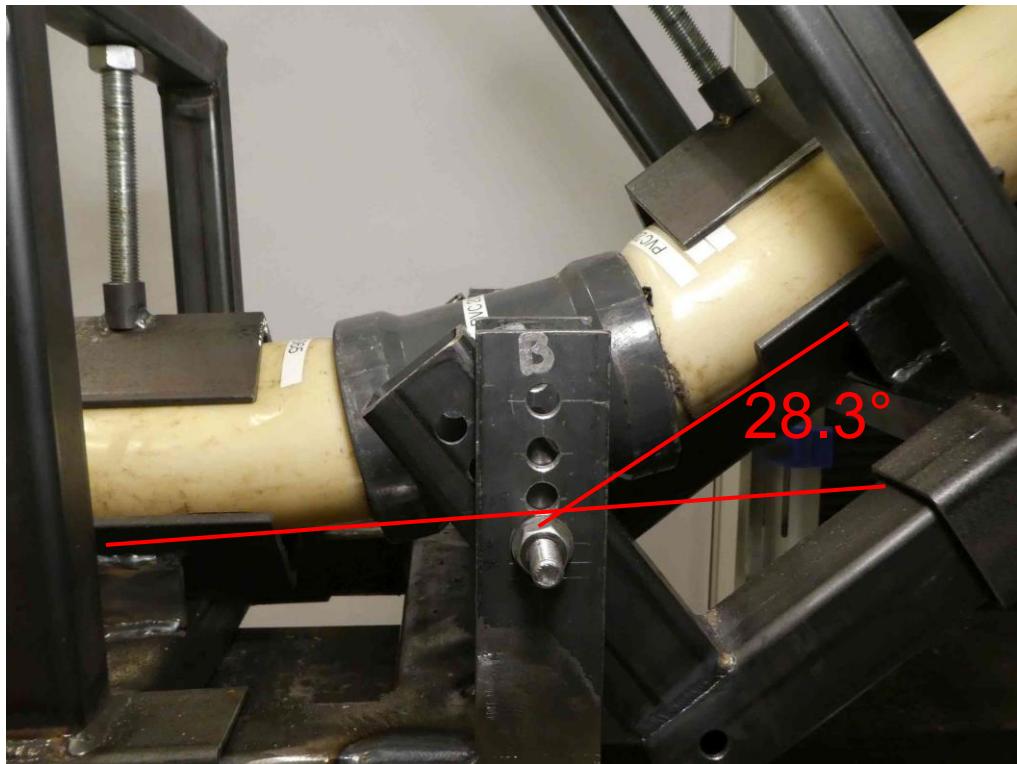
Figure 19 Angle of deflection at the moment of leakage of unaged PVC 2012-064

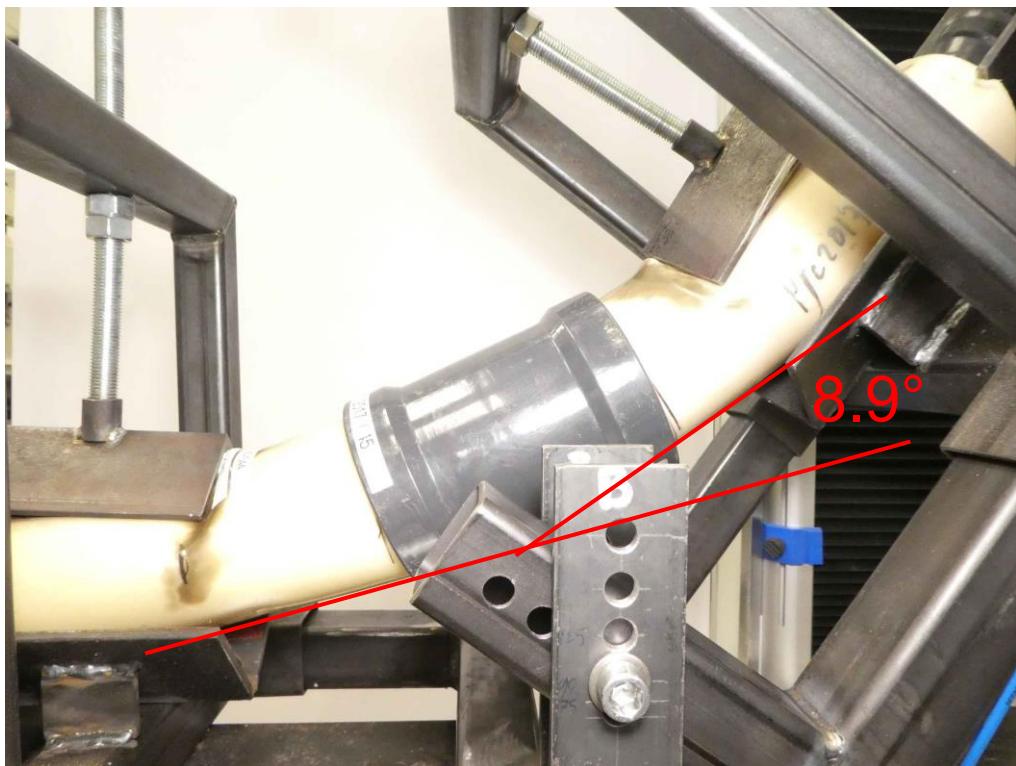
Figure 20 Maximum angle of deflection of test rig reached (PVC 2017-045). No leakage occurred
