PLASTIC SHEET MATERIAL: AN EXCELLENT PROTECTION OF PVC PIPES AGAINST UV-DEGRADATION

MSc. J. Weller
Kiwa Technology
Apeldoorn, The Netherlands
jeroen.weller@kiwa.nl

ABSTRACT

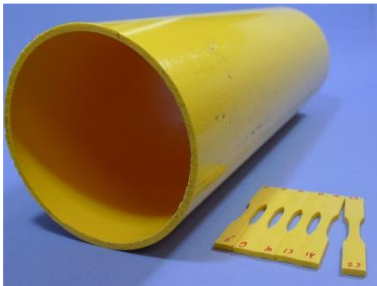
Figure 1: PVC-HI pipe with dumbbell-shaped specimens.

When trying to determine the remaining quality of a material, it is important to look at its lifetime-limiting failure mechanism. Field failure studies of fractured PVC gas pipes in the Netherlands have shown that a lack of ductile behaviour is the most important reason for incidents involving PVC pipes. Spontaneous failure hardly ever occurs in PVC pipes in the Dutch gas grid and most failures originate from third-party damage (i.e. damage caused by digging) [5]. If a PVC pipe fails, it is important that it does so with a ductile fracture, as brittle fractures result in larger gas outflows, and repairing brittle pipes (e.g. when sawing) is more difficult and therefore slower. So brittle PVC pipes pose a greater safety risk, making embrittlement a limiting factor in the service life of PVC pipes. Therefore the ductility of the excavated pipes in the Exit Assessment programme is tested using a tensile-impact test. For this a newly improved test method was developed at Kiwa Technology [1]. From each individual pipe dumbbell-shaped test samples are milled, see figure 1. In turn these dumbbells are broken with high impact velocity at temperatures varying from -25 to +50°C, see figures 2 and 3.

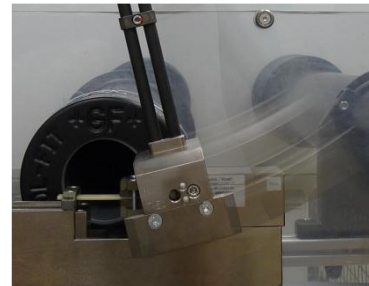
Figure 3: Impact on a specimen.

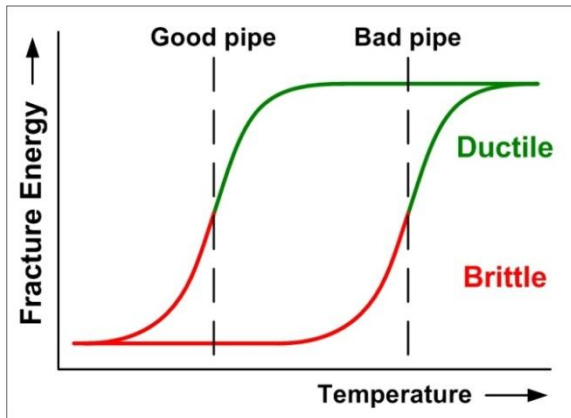
Figure 6: Schematic graph of the brittle-ductile-transition-temperature for a good and a bad PVC pipe.

The fracture behaviour of PVC does not only depend on the material quality, but is also strongly influenced by its temperature. This is where the brittle-to-ductile-transition-temperature (T_{BD}) plays an important role. This is the temperature where the material behaviour under impact changes from brittle to ductile. A low transition temperature represents a good PVC material and a high one a poor PVC material. The theoretical graph of the transition temperature of a good and a bad PVC pipe is given in figure 6. The experimental graphs look like shown in figure 7. As can be seen the transition temperature is clearly visible, except for some scatter. This is normal and intrinsic to PVC material properties, since PVC is an inhomogeneous material by nature.

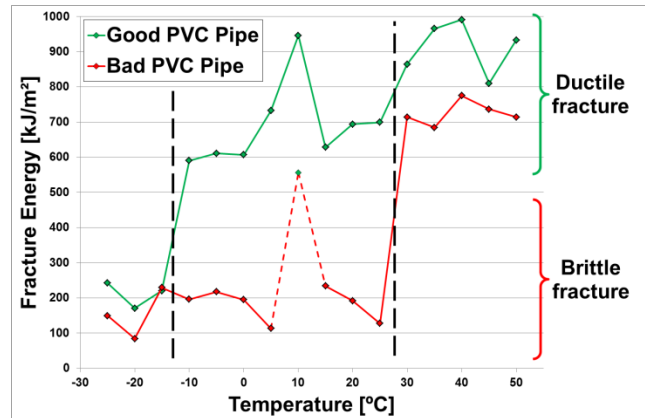
Figure 7: Graph of the brittle-ductile-transition-temperature for a good and a bad PVC pipe in practise.

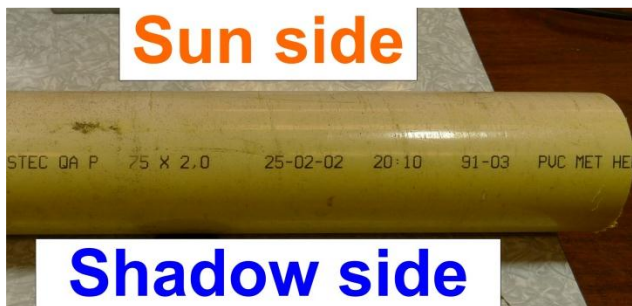
Figure 8: PVC pipe where the discolouration of the sun side is visible.

1. One PVC-HI (CPE) pipe that had been exposed to direct sunlight for a year at Kiwa Technology (exposure from October 2011 to October 2012)
2. One PVC HI (PVC-A) that had been outside for almost 7 years at a DSO, see also figure 8.

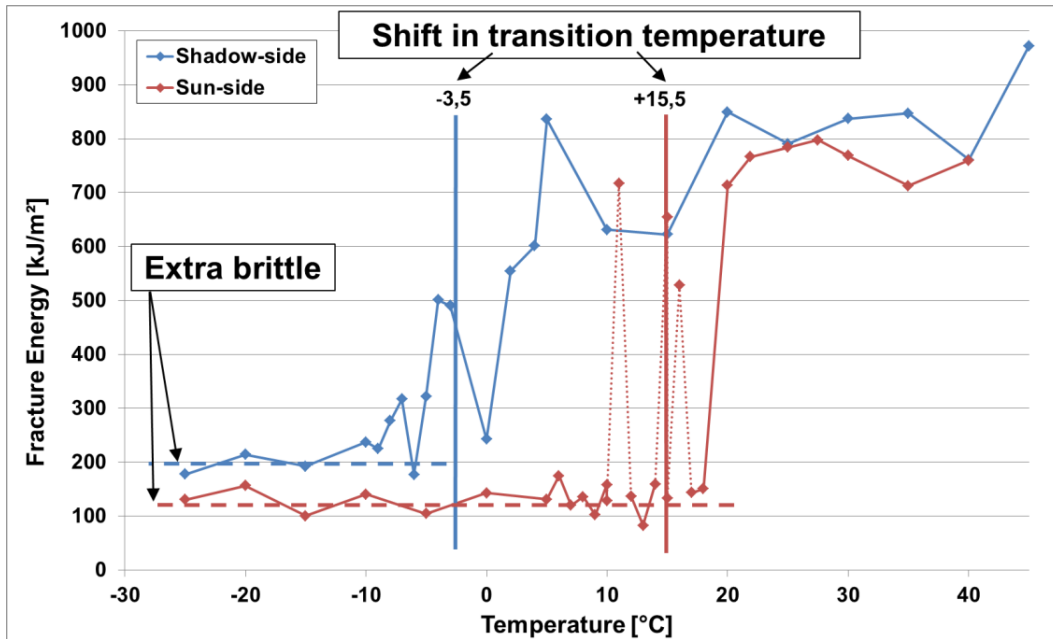
Figure 10: Graph of impact results of specimens from the sun and shadow side of the PVC-HI (CPE) pipe that was exposed to direct sunlight for a year.

The test temperature is on the horizontal axis. The energy needed to break the specimens is on the vertical axis. The blue line represents the shadow side of the pipe and the red line the sun side. It can be seen that the transition temperature of the sun-side material (+15,5°C) is considerably higher than the shadow-side (-3,5°C). This is relevant since the average ground temperature in The Netherlands is 10°C, with variations from about 0°C to +20°C. So this shift takes place exactly in the temperature range in which the pipes are utilized. Besides the shift in transition temperature the average energy needed to break the brittle specimens is also lower on the sun-side compared with the shadow-side (extra brittle).

Both pipes were divided in a “Sun side” and a “Shadow side”, which in turn have been milled into dumbbell-shaped specimens, see figure 9. These samples have been tested at different temperatures. Looking at these individual specimens, the discolouration by the sun is clearly visible. The results of the pipe that was exposed for 1 year is shown in figure 10.

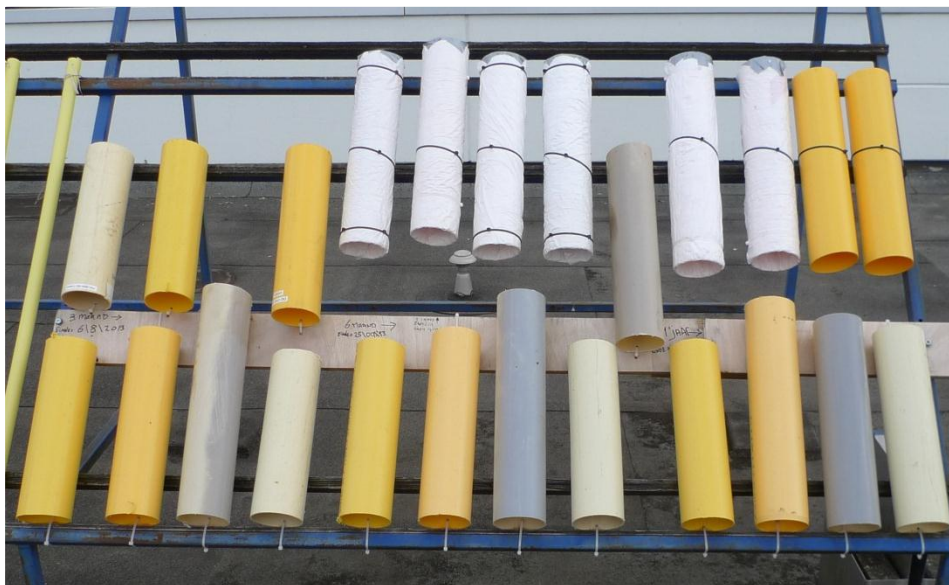
Figure 14: Overview of the pipes being exposed outside.

These pipes were exposed for 1, 3, 6 and 12 months in The Netherlands, Apeldoorn. The 1, 3 and 6 months exposure time were all divided in an equal period before and after the 21st of June 2013, to ensure worst case scenario exposure. The 12 months exposure was tested from March 2013 to March 2014. Additionally the PVC-HI (CPE) and PVC-HI (A) pipes were exposed, wrapped in standard packaging sheets and exposed for 3 and 11,5 months, to assess the effect of the protective sheet. For an overview, see figure 14.

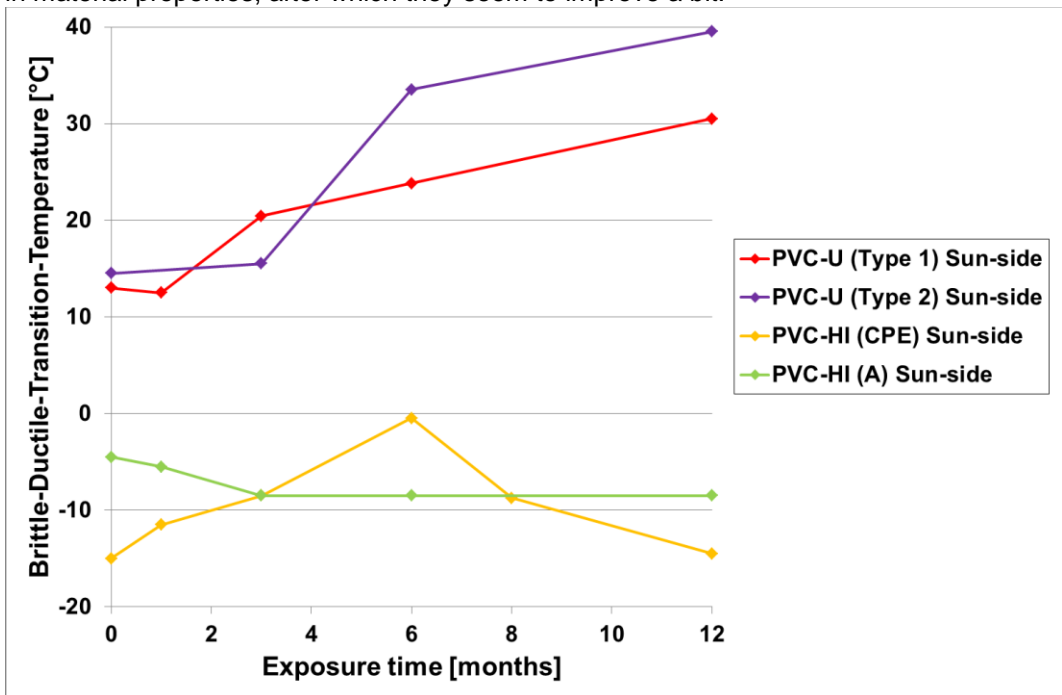
Figure 18: The transition temperatures for PVC-U type 1, PVC-U type 2, PVC-A (HI) and PVC-CPE (HI) of the sides of the pipes after different exposure times (sun-side only).

Adding the PVC-HI measurements makes a different trend visible, see figure 18. The PVC-A (green line) does not seem to be influenced by the exposure to the sun in the first year and the transition temperature stays between -4,5°C and -8,5°C. Visual inspection of the individual specimens after one year exposure shows a discolouration that seems rather limited, see figure 19.

The PVC-CPE shows more discolouration after 1 year than PVC-A, see figure 20. However it starts with an initially lower transition temperature of -15°C (orange line, figure 18). After 6 months of direct exposure to sunlight the transition-temperature has shifted to 0°C . And then something peculiar happens. The transition-temperature shifts back to $-14,5^{\circ}\text{C}$. Meaning that the impact properties improve between months 6 and 12.

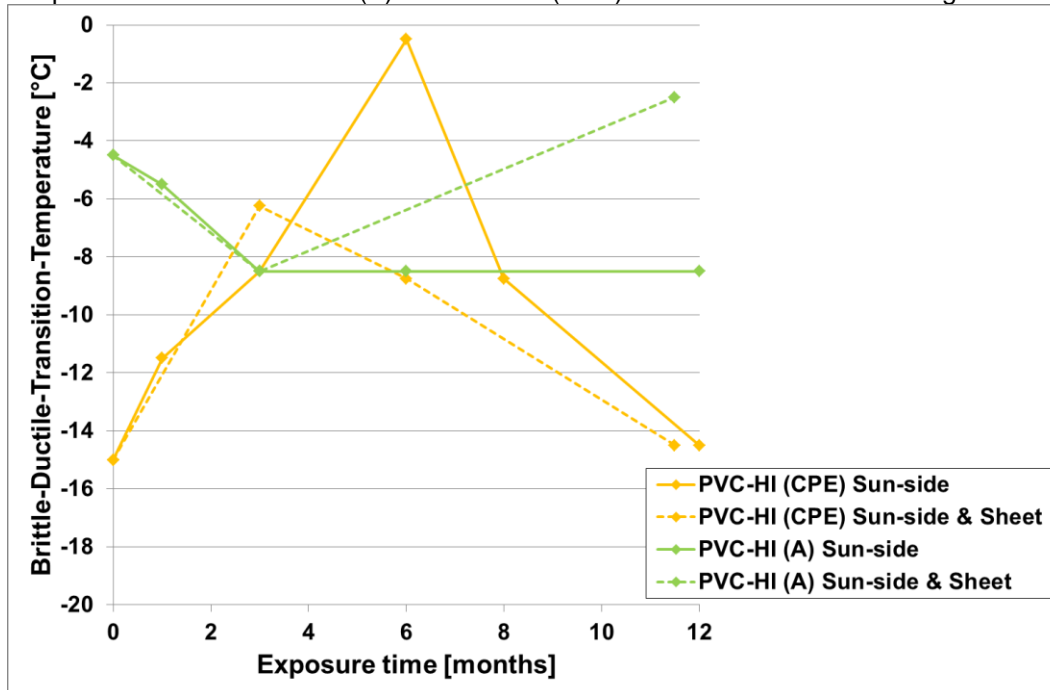
Figure 21: The transition temperatures for PVC-HI (A) and PVC-HI (CPE) with sheet protection and without versus exposure times.

It is noticed that the effect of the direct sunlight on the PVC-HI (CPE) material is suppressed, compared to the PVC-HI (CPE) without the sheet. For the PVC-HI (A) there was no effect by direct sunlight to begin with, and now there even seems to be a slight increase in transition temperature with the protective sheet. Visual inspection of the specimens in figure 19 and 20 shows that after one year no discolouration has taken place on the sun side of the pipes with the protective sheets. This strongly indicates that chemical degradation by direct sunlight has been prevented.

To investigate the protective property of the protection sheets a comparison between the transition-temperatures of both PVC-HI (A) and PVC-HI (CPE) with and without sheets is given in figure 21.
