MAKING THE ACCELERATED NOTCH PIPE TEST (ANPT) FUTURE-PROOF

This paper describes a study that compared the horizontal and vertical test positions in the Accelerated Notch Pipe Test. The study also explored the use of Dehyton® PL as an accelerating detergent to replace Arkopal® N100.

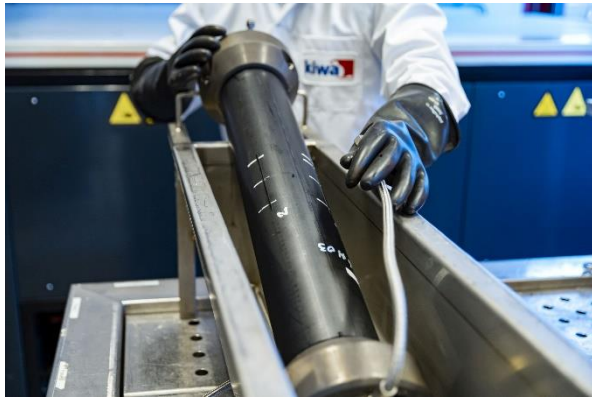
Figure 1. Placement of the test pipe in the horizontal container (still without detergent solution).

The test pipe was placed in a small container with the detergent solution (2 wt% active component*). Special containers were used for each alignment, i.e., horizontally or vertically (figure 1 and figure 2).

The horizontal containers had a V-shaped base containing a perforated steel tube. The detergent solution entered through the perforated steel tube. One end was connected to a circulation pump in the upper part of the container. The test pipe rested on the end caps to leave enough space for proper circulation of the detergent solution around the test pipe. Special tests with colorant confirmed the homogeneous distribution of the detergent solution throughout the container [22].

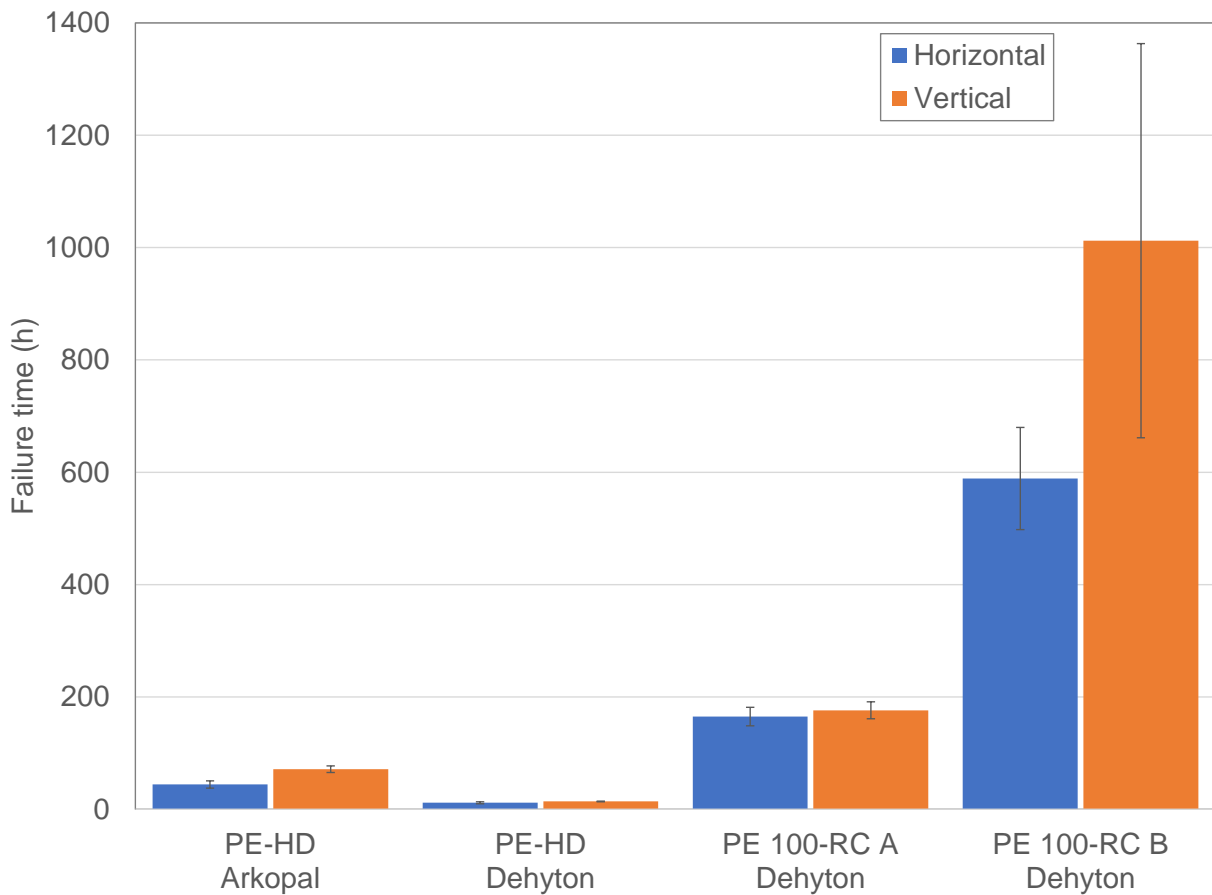
Figure 3. ANPT test failure times (average and standard deviation) in the horizontal and vertical test containers using three different materials and two detergents.

The results are given in table 1 and displayed graphically in figure 3. 58 test pipes made from PE-HD were tested in the vertical containers to determine the statistical uncertainty caused by the equipment. Fewer pipes were used for the other tests.

It is clear that the failure times for the samples in the horizontal containers were shorter than for those in the vertical containers. The same result was also found in the interlaboratory comparison of the ANPT as performed by the PE100+ Association. The report states that “*The position of the samples did show some difference in failure times with the horizontal position to obtain in this round robin test lower failure times.*” [5].

The cause of this difference is the most pertinent question. It is very likely that it is related to the detergent flow inside the container. For example, the vertical containers are round, while the horizontal containers are not, which means the flow will differ between the two types of containers.

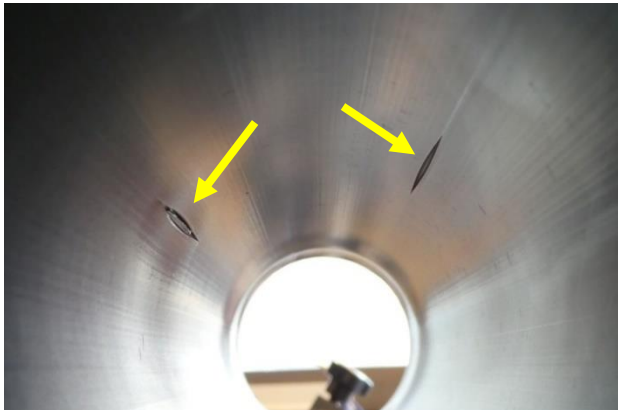
Figure 6. Pipe failure after testing in the horizontal container. Two cracks are visible at the top of the pipe (yellow arrows), although only one has failed.

However, all pipes that were tested in the horizontal containers (including tests not described in this paper) failed at notch 1 or 4 (see figure 6). The other notch often started to fail as well (see figure 7), as described in the previous paper [22].

These results seem to indicate that gravity and a lack of refreshment of the detergent solution around notches 1 and 4, affected the failure time of these notches. The local environment around the notch tips of notches 1 and 4 seemed to be more aggressive. This may be because the Dehyton® concentration was higher at these locations. This resulted in earlier failure than with notches 2 and 3 in the horizontal position, or with any of the notches in the vertical position.

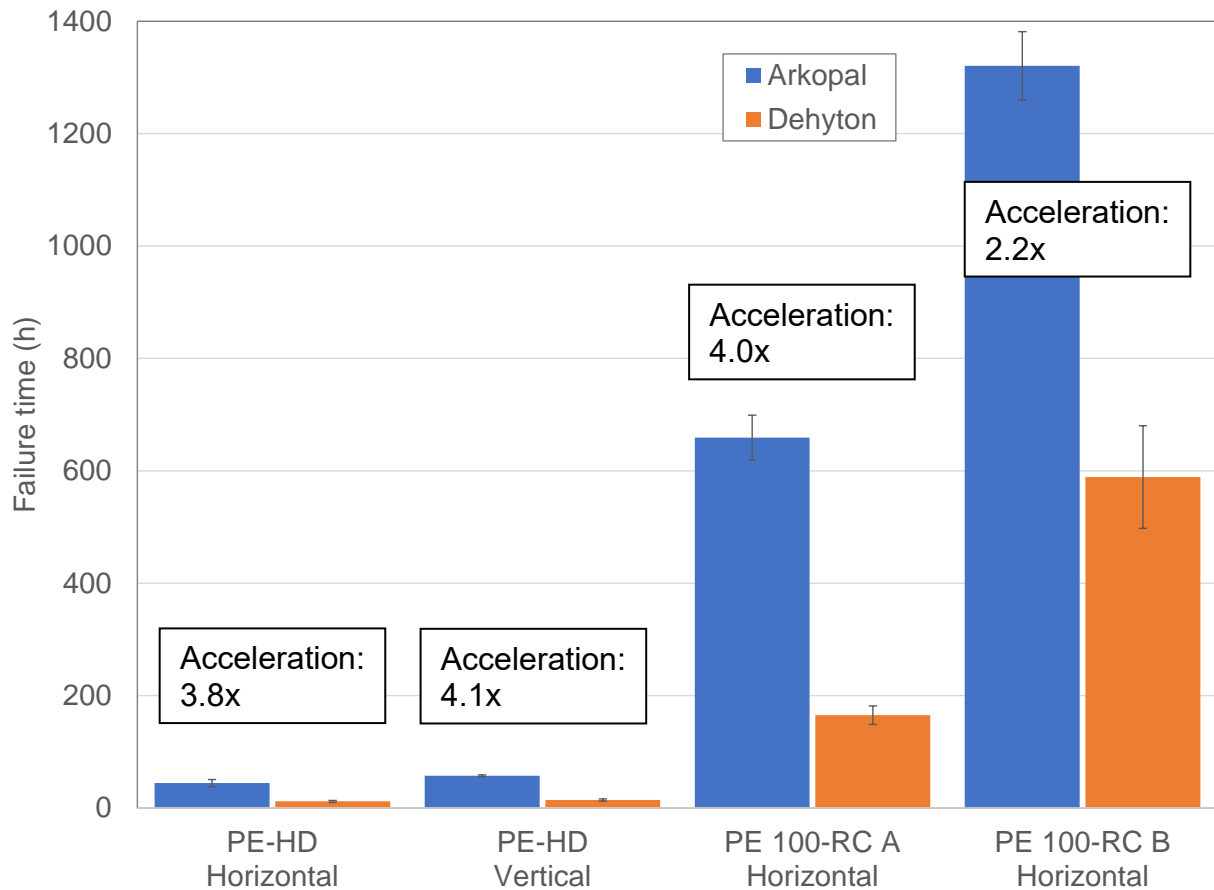
Figure 8. ANPT test failure times (average and standard deviation) for Arkopal® N100 and Dehyton® PL using three different materials in the horizontal and vertical test containers.

The results are given in table 2 and displayed graphically in figure 8.

The acceleration factor ranges between 2.2 for PE 100-RC B and about 4 for PE-HD and PE 100-RC A. TGM published results of comparative tests with Arkopal® N100 and Dehyton® PL in ISO/TC138/SC5/WG20 [6]. They identified an acceleration factor of 2 for six different PE 100-RC grades. The acceleration varied somewhat more for five different PE 100 grades, which resulted in an acceleration factor between 2 and 8.
